TECHNICAL REPORT GL-87-14

SEISMIC STABILITY EVALUATION OF FOLSOM DAM AND RESERVOIR PROJECT

Report 3 CONCRETE GRAVITY DAM

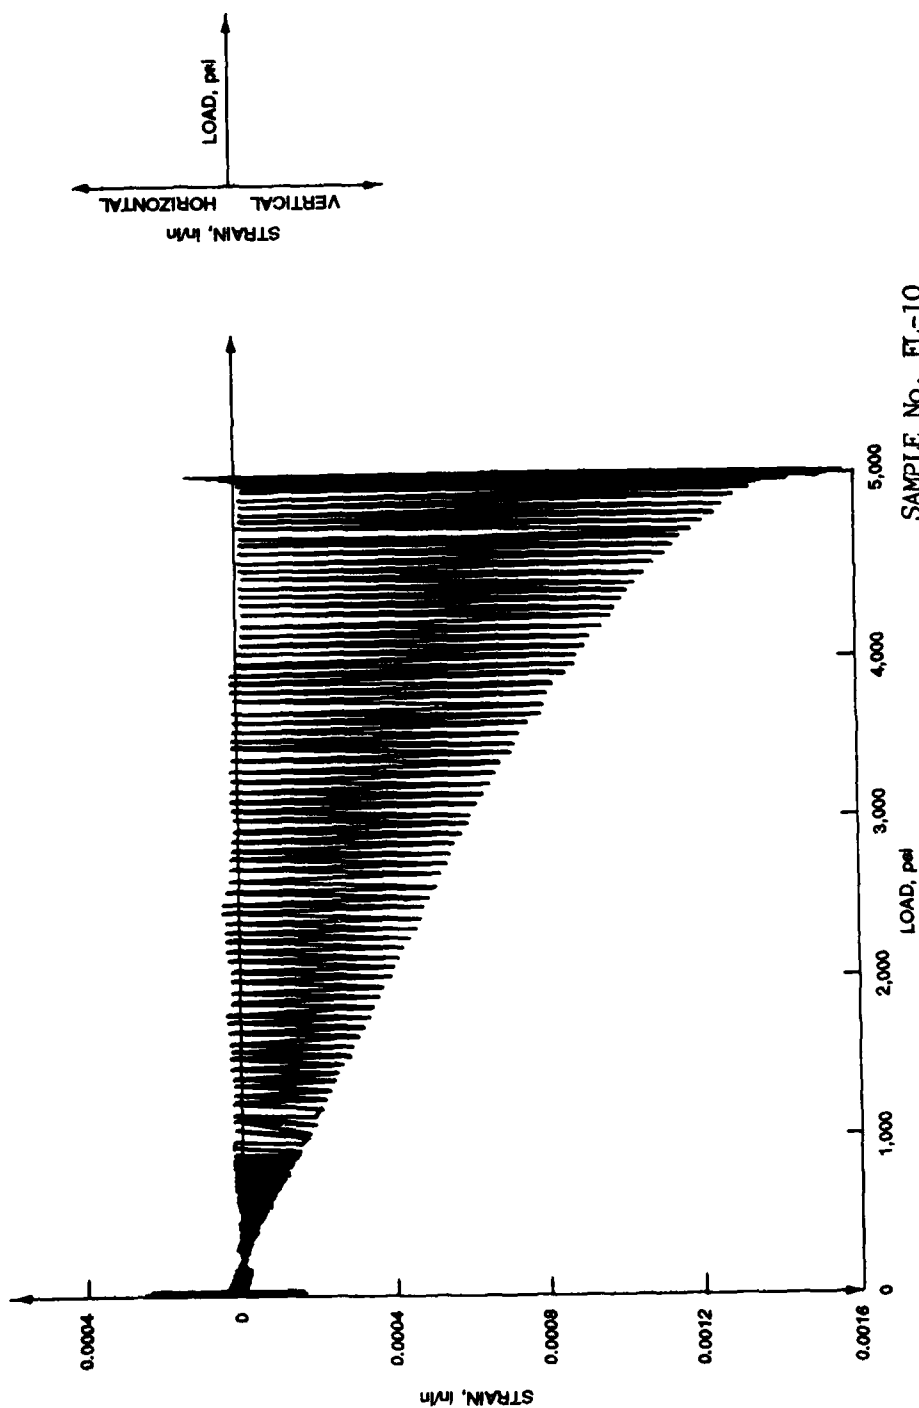
Figure C.6 Concrete Test Data for Sample No. FL-10

SAMPLE No. FL-10

TENSILE STRENGTH = NOT AVAILABLE
 COMPRESSIVE STRENGTH = 4633 psi
 CHORD MODULUS OF ELASTICITY = 1.930E + 06
 POISSON RATIO = 0.083

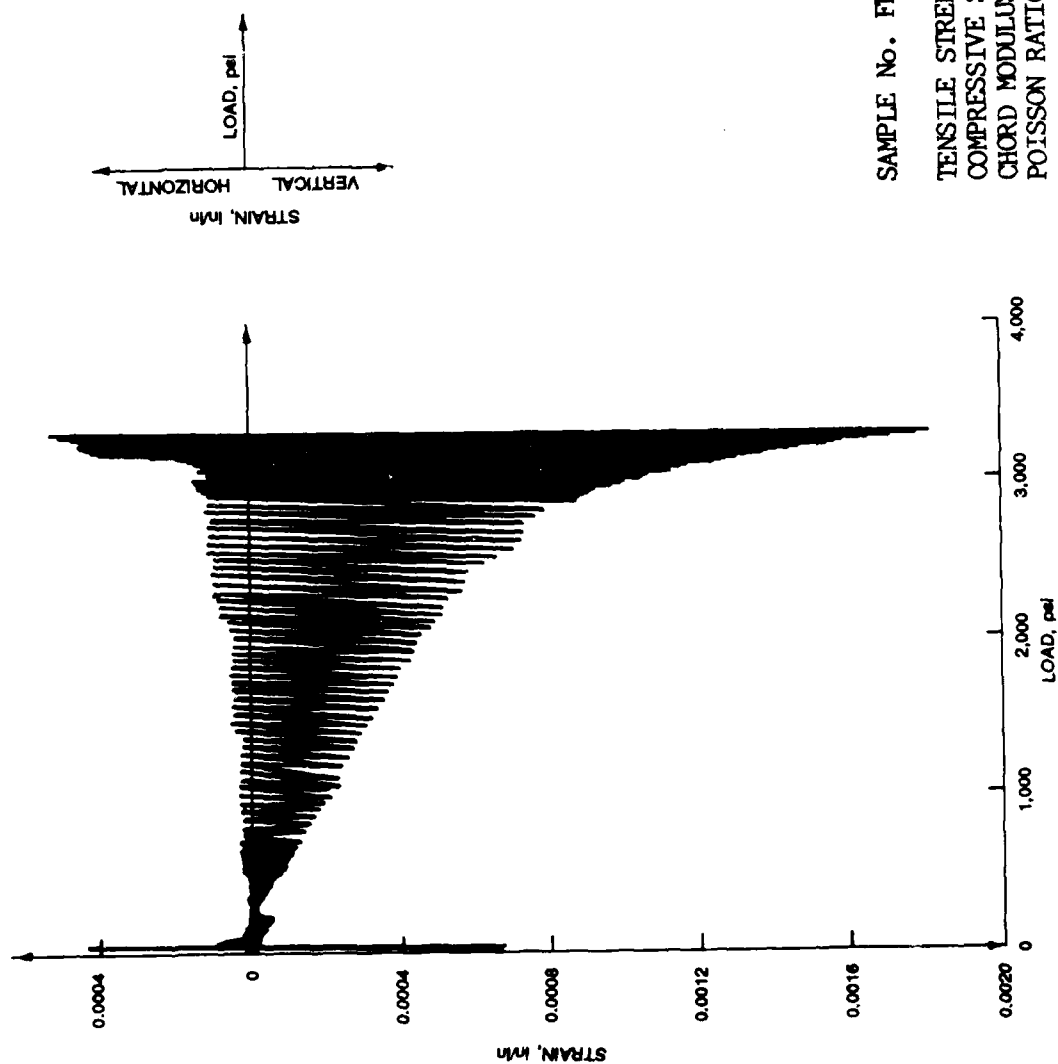
Figure C.8 Concrete Test Data for Sample No. FL-12

SAMPLE No. FL-12

TENSILE STRENGTH = NOT AVAILABLE
 COMPRESSIVE STRENGTH = 2936 psi
 CHORD MODULUS OF ELASTICITY = $1.677E + 06$
 POISSON RATIO = 0.171

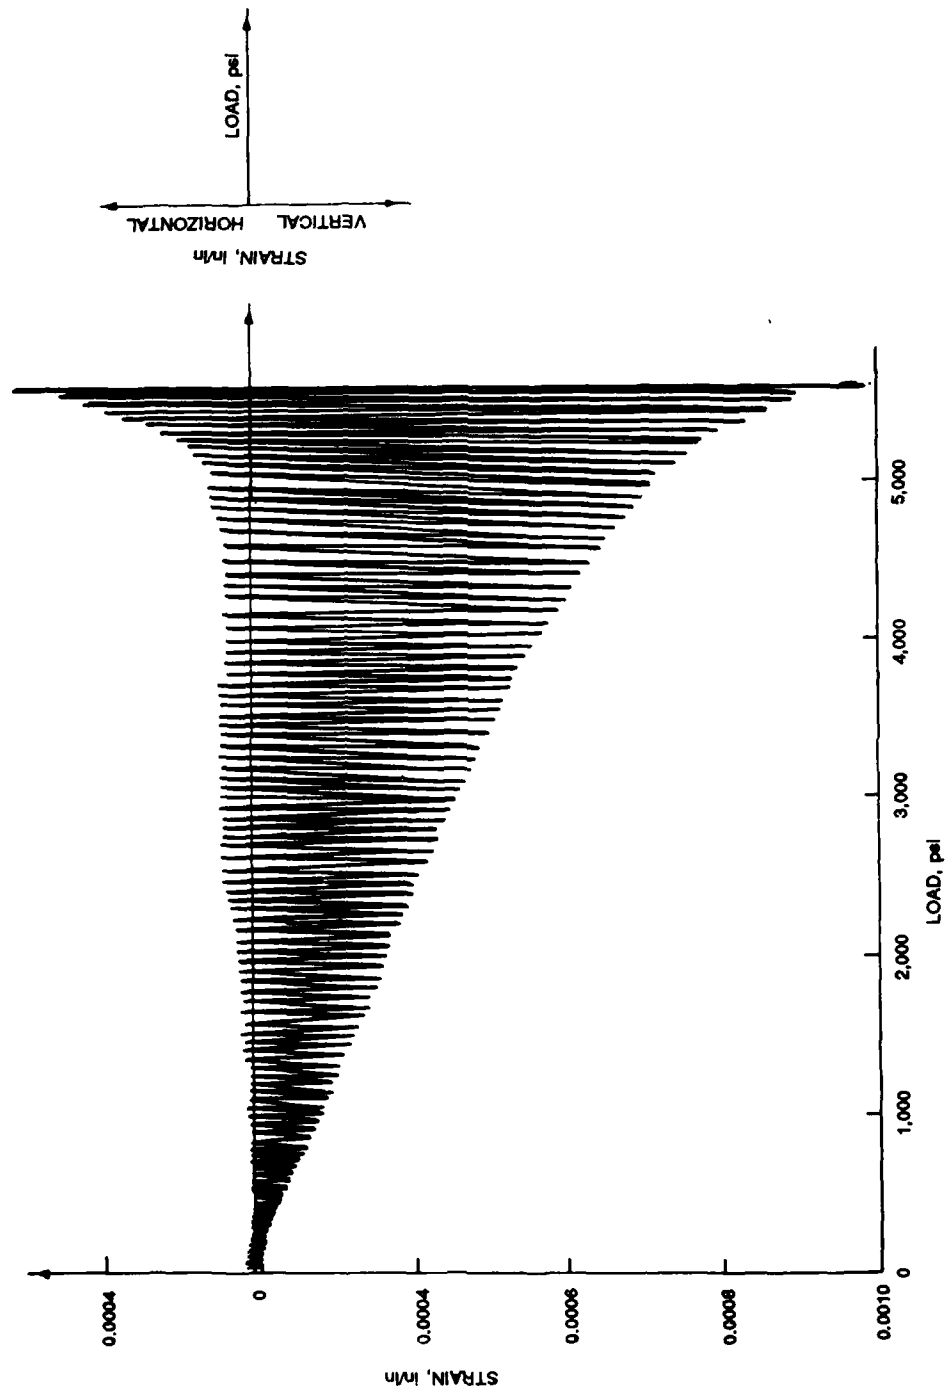
Figure C.9 Concrete Test Data for Sample No. FL-15

SAMPLE No. FL-15

TENSILE STRENGTH = NOT AVAILABLE
 COMPRESSIVE STRENGTH = 4987 psi
 CHORD MODULUS OF ELASTICITY = $2.168E + 06$
 POISSON RATIO = 0.130

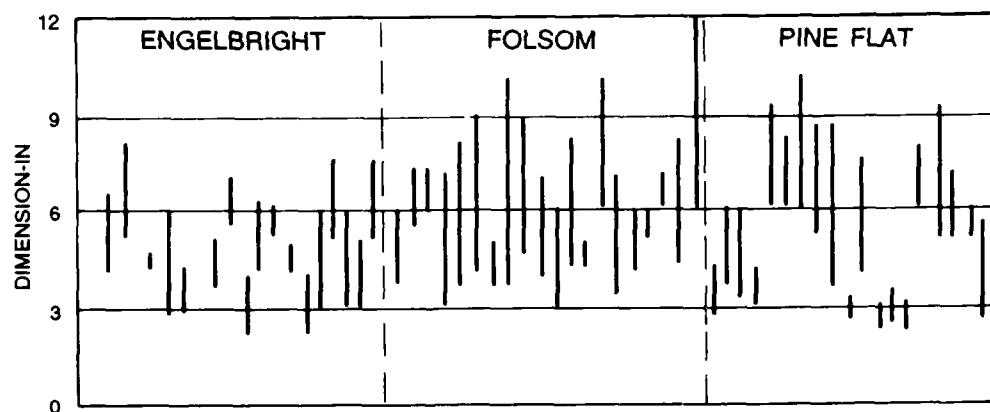
Figure D1. Length and width of largest aggregate

UCB report. Each line shows the length and width of the largest aggregate in each of the cores tested for elastic properties. Percentages of cores with particles larger than 6-in. were as follows: Engelbright - 50 percent, Folsom - 90 percent, Pine Flat - 60 percent. In large aggregate concrete, there is water gain during setting under each large particle, resulting in a layer of significantly lower strength mortar, or laitance, at the interface.

8. The cores used in the USBR/COE tests were 6-in. diameter. Following my recommendations, the cores tested at UCB were 12-in. diameter. Figure C1 is a graphic representation of the data in Tables 3, 4, and 5 of the

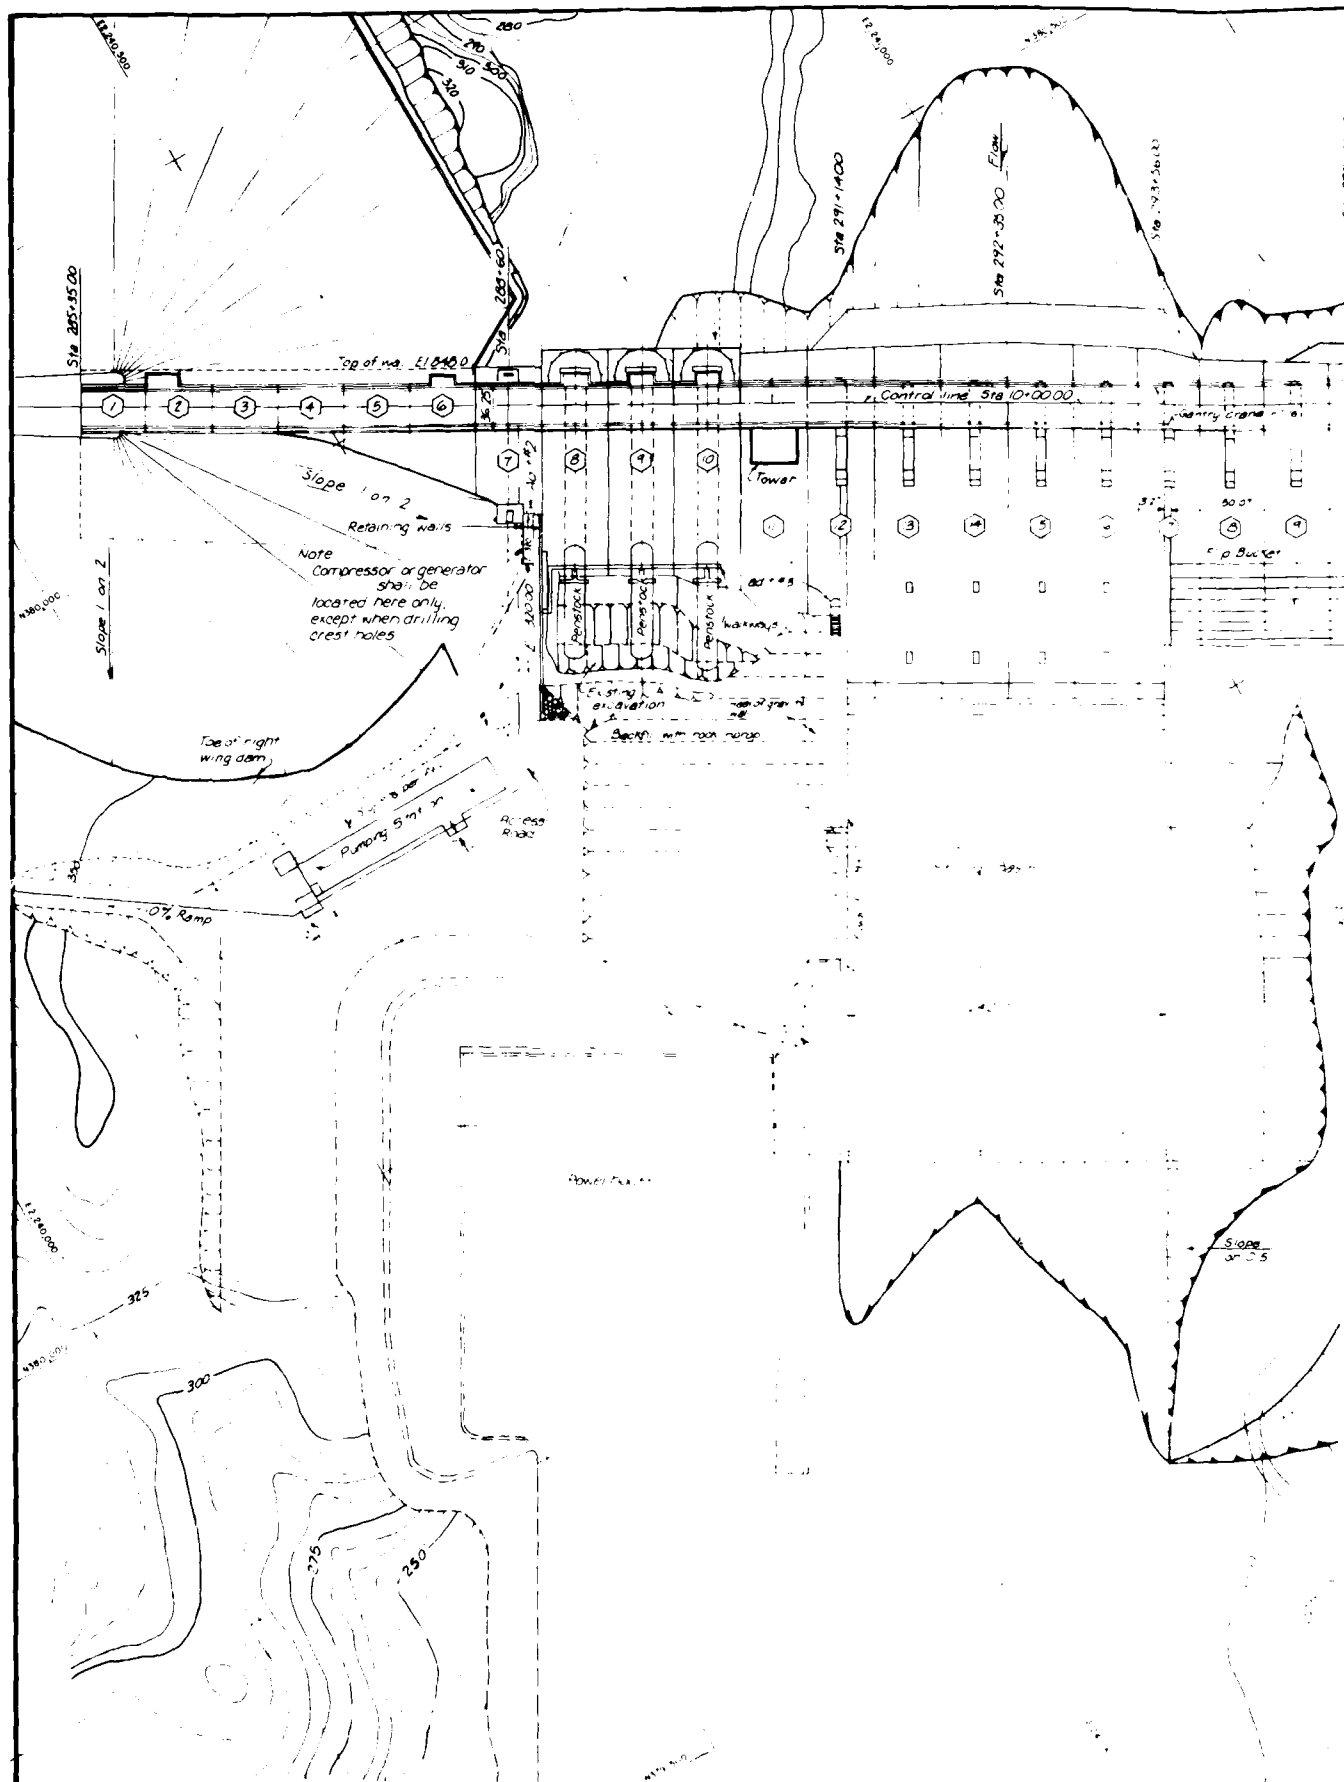
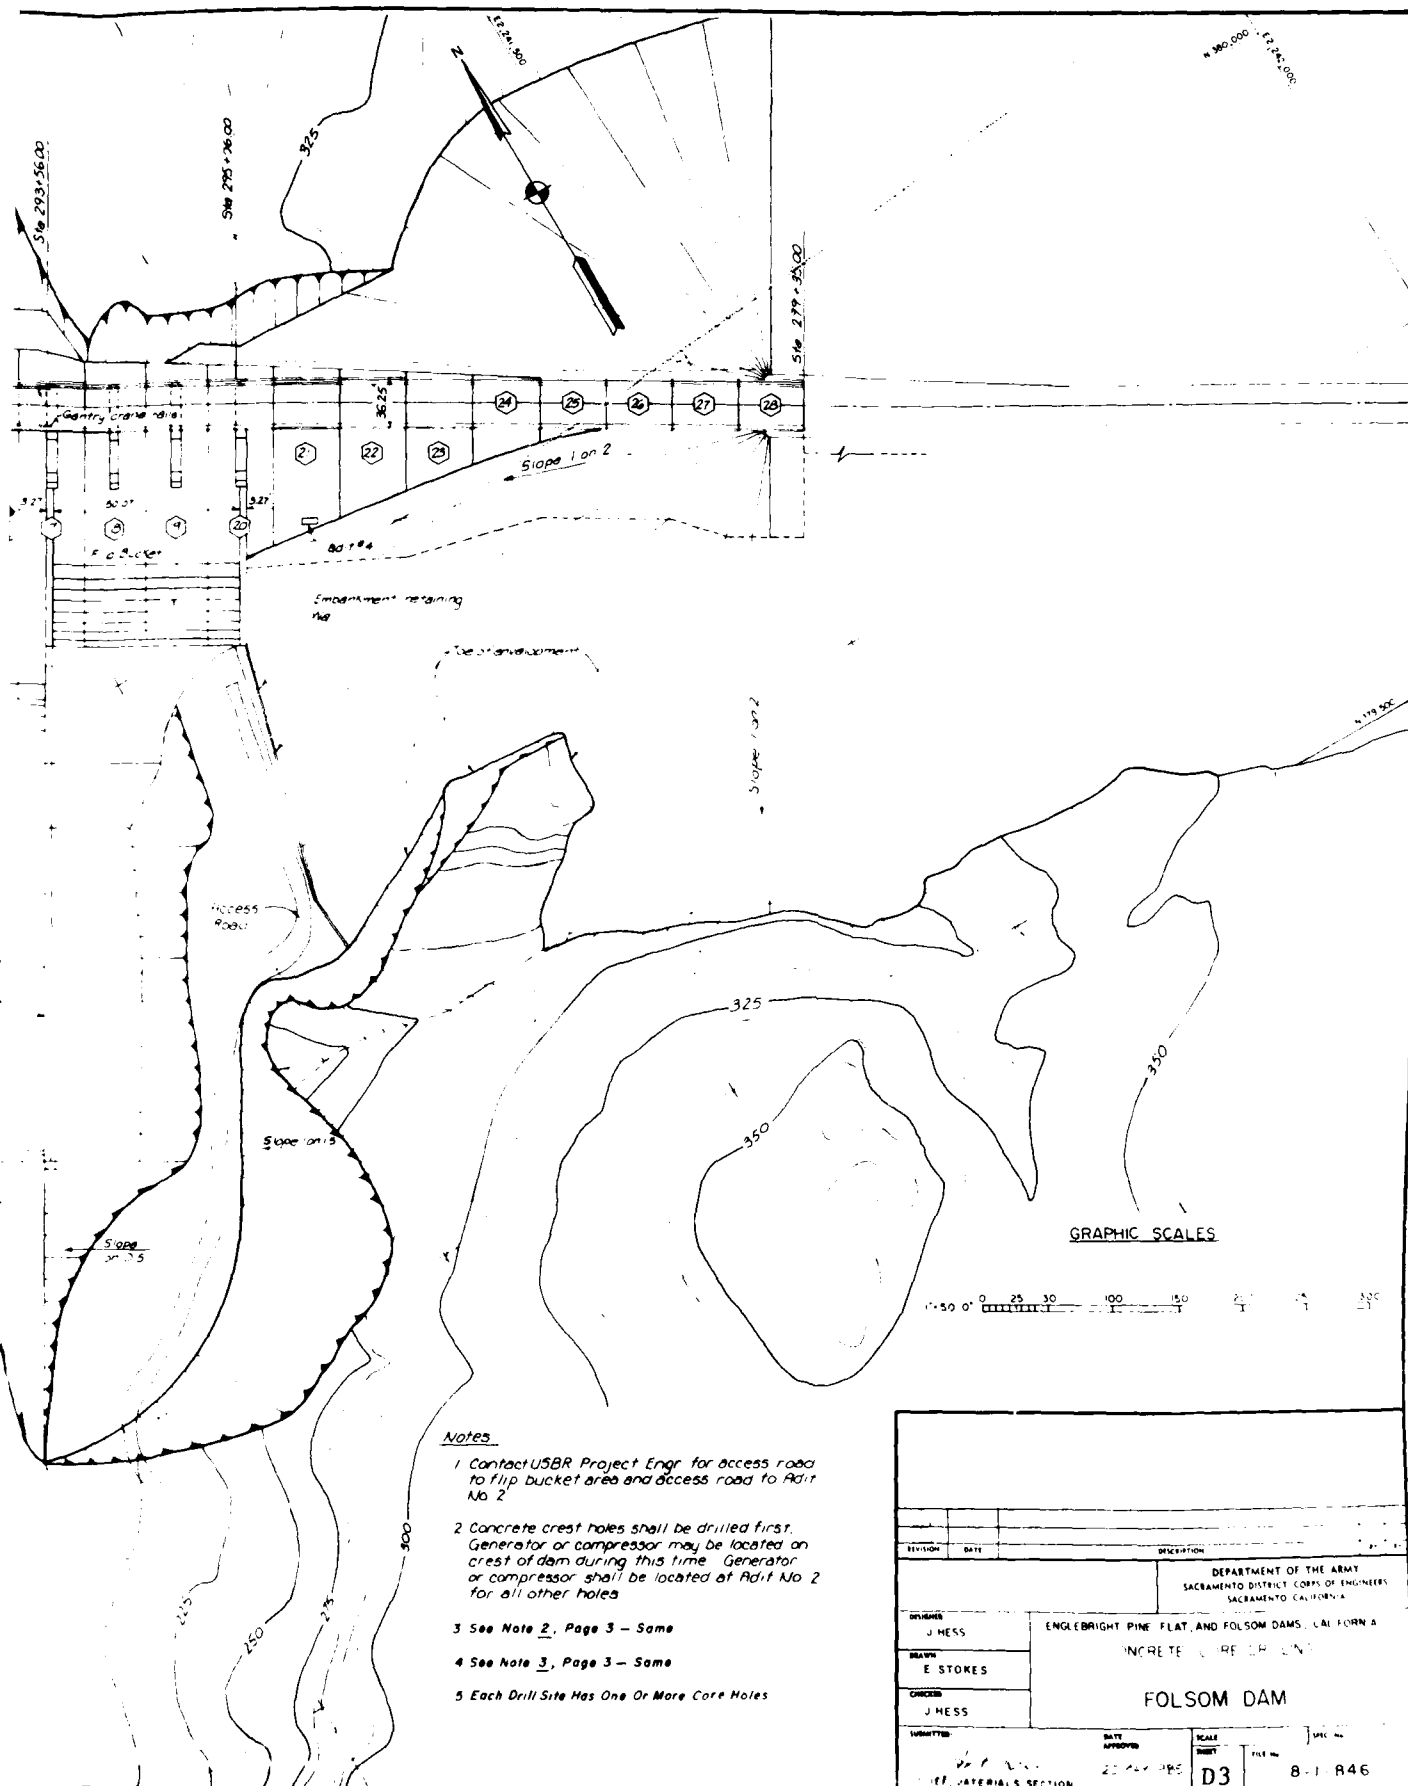
21. Figures D3 through D6 show the drilling locations for the cores taken from Folsom Dam for the UCB tests.

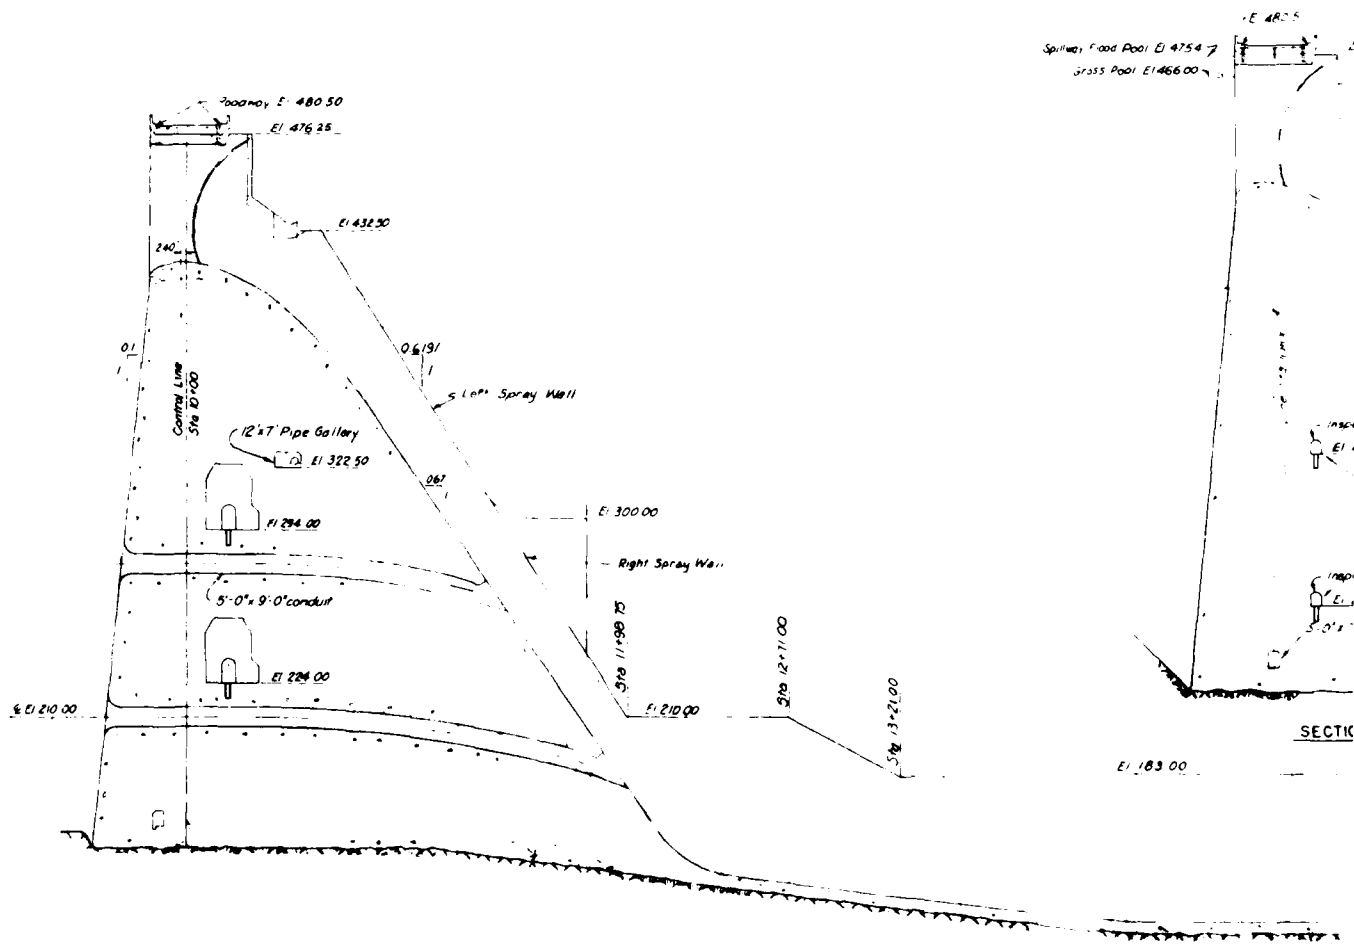
SECTION THRU STILLING BASIN

SCALE 1" = 30'

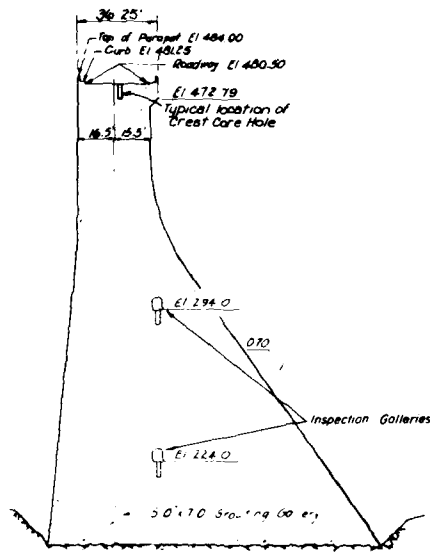
TYPICAL NON-OVERFLOW SECTION

STA 236+0 MONOLITH NO. 22
SCALE 1" = 50'

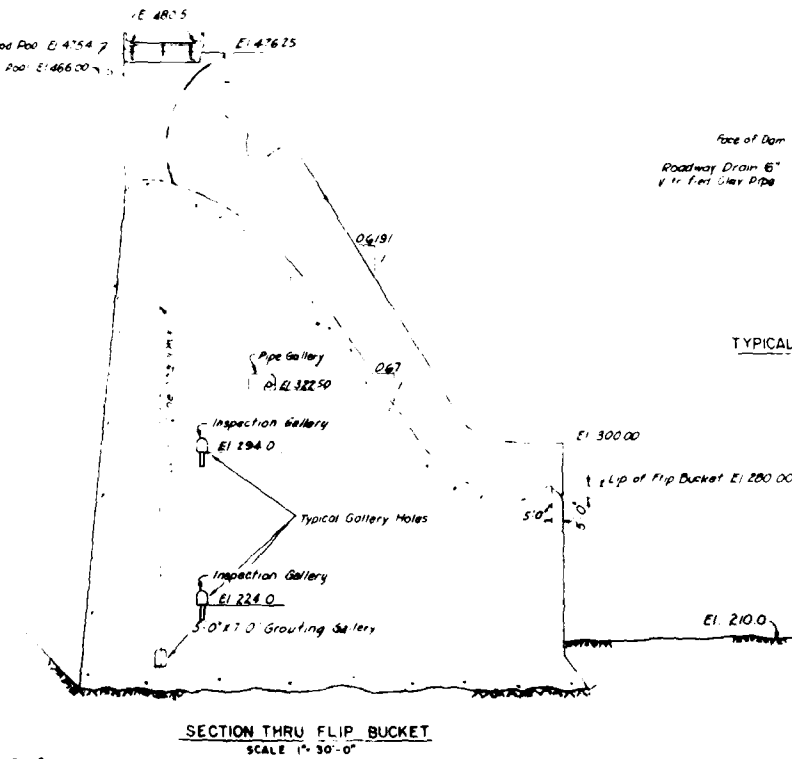
SECTION THRU FLIP BUCKET
SCALE 1" = 30'-0"

El. 183.00

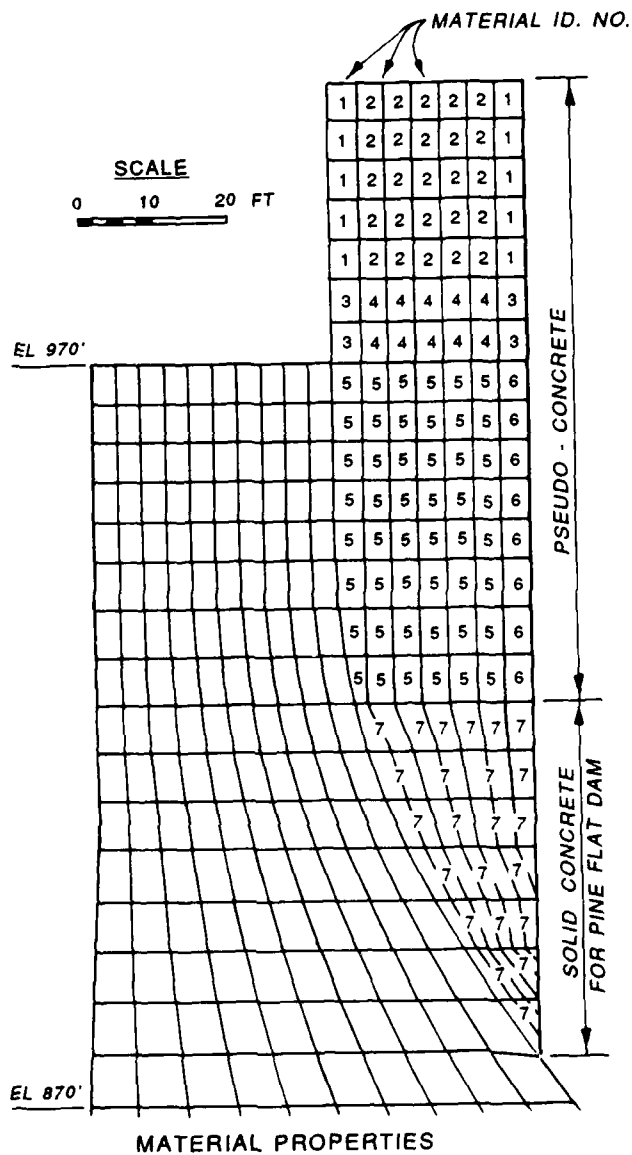
Figure F6. Pine Flat tower model

<u>MATERIAL NO</u>	<u>M</u> <u>(K-SEC²/FT⁴)</u>	<u>E</u> <u>K/FT²</u>
1	0.001178	125608.6
2	0.0004193	44775.76
3	0.001509	173786.8
4	0.0005565	64907.85
5	0.0005621	65570.48
6	0.0015183	175652.3
7	0.004907	849600

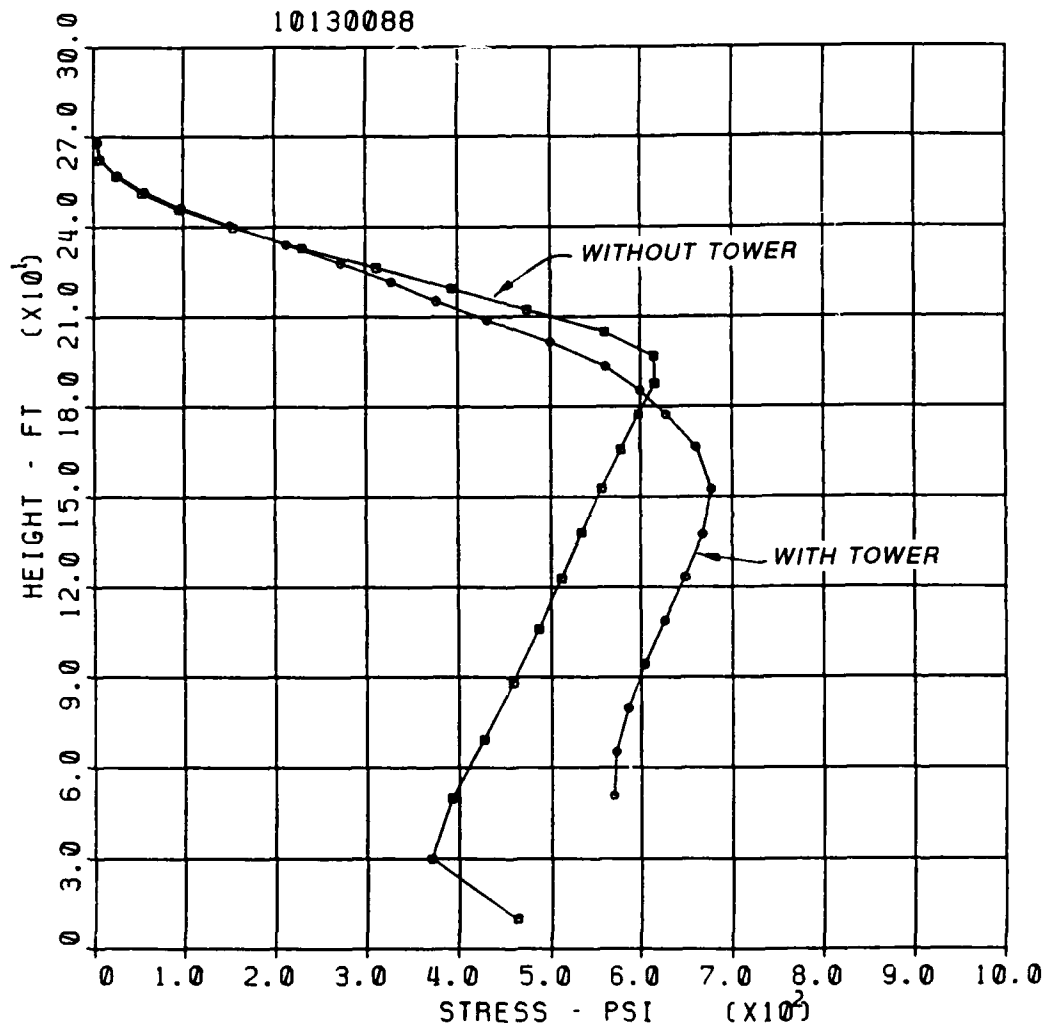
WITH AND WITHOUT TOWER - SIGMA-1 UPST

Figure F12. Maximum principal stress along upstream face
with and without tower

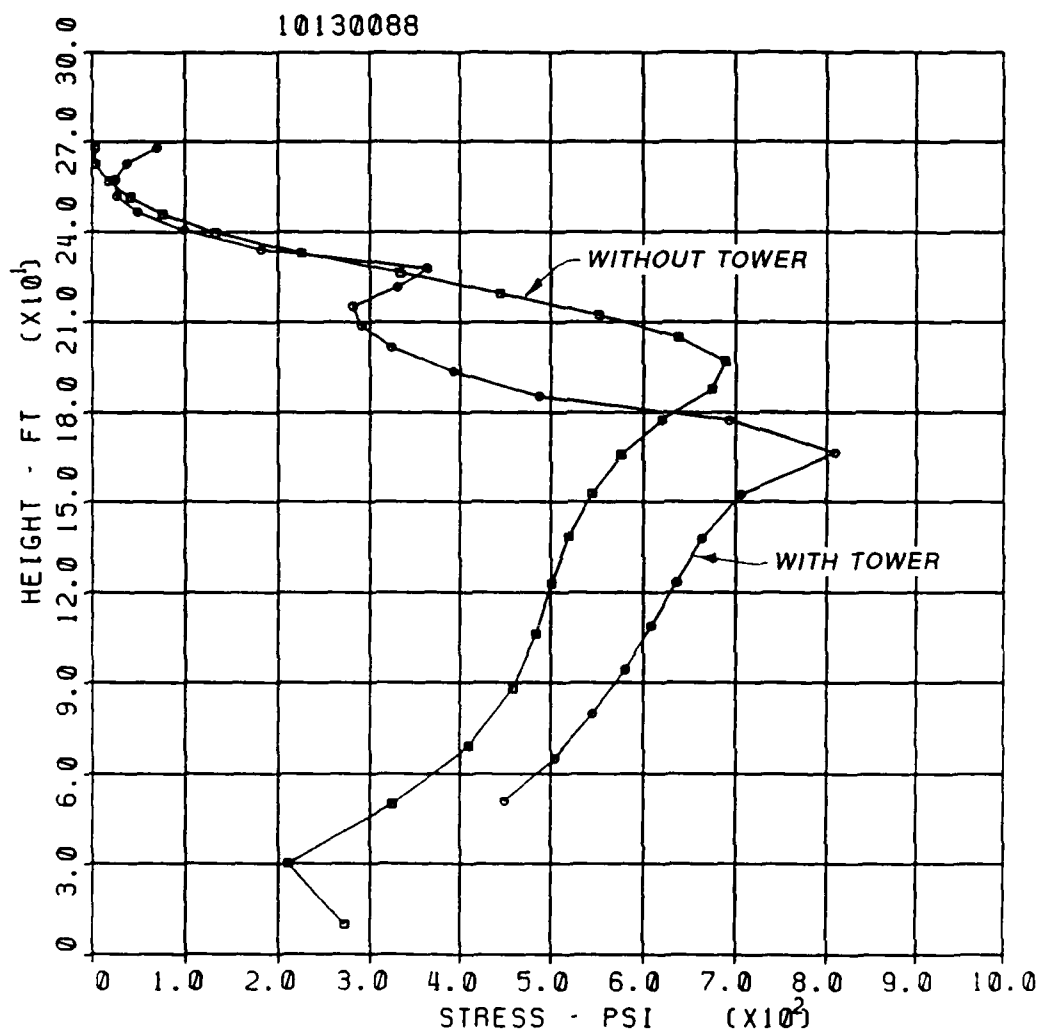
WITH AND WITHOUT TOWER - SIGMA-1 DOWN

Figure F13. Maximum principal stress along downstream face
with and without tower

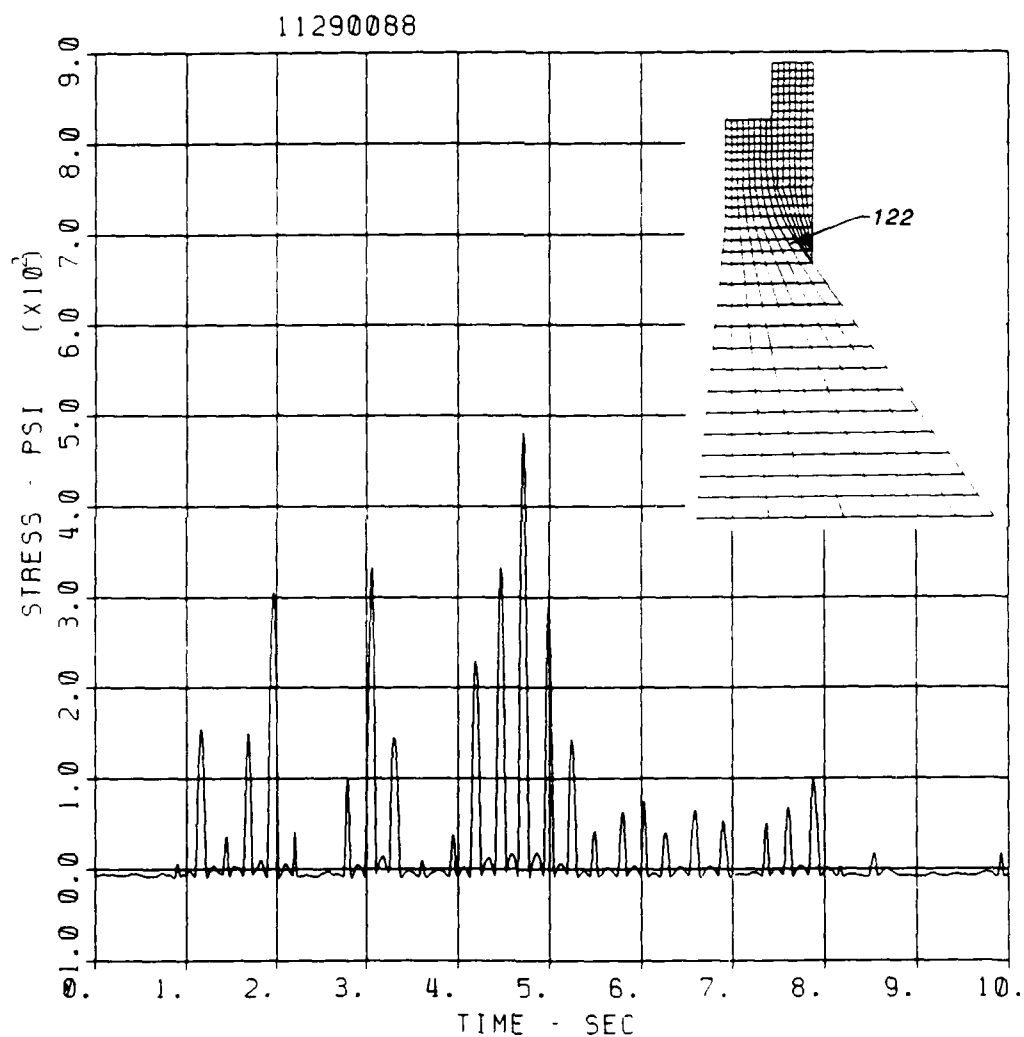
NONFLOW SECTION WITH SIGMA-1 ELE NO. 122

Figure F14. Principal stress time history for element 122

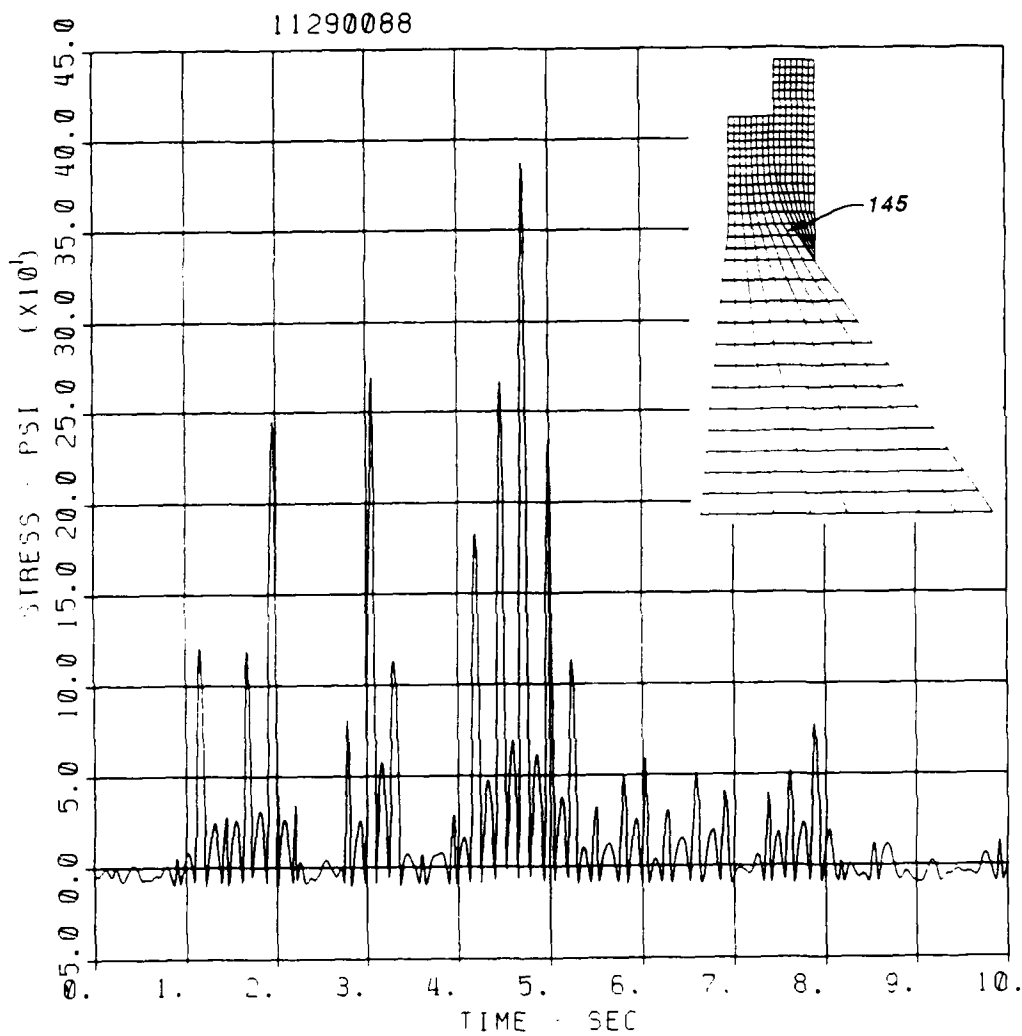
NONFLOW SECTION WITH SIGMA-1 ELE NO. 145

Figure P15. Principal stress time history for element 145

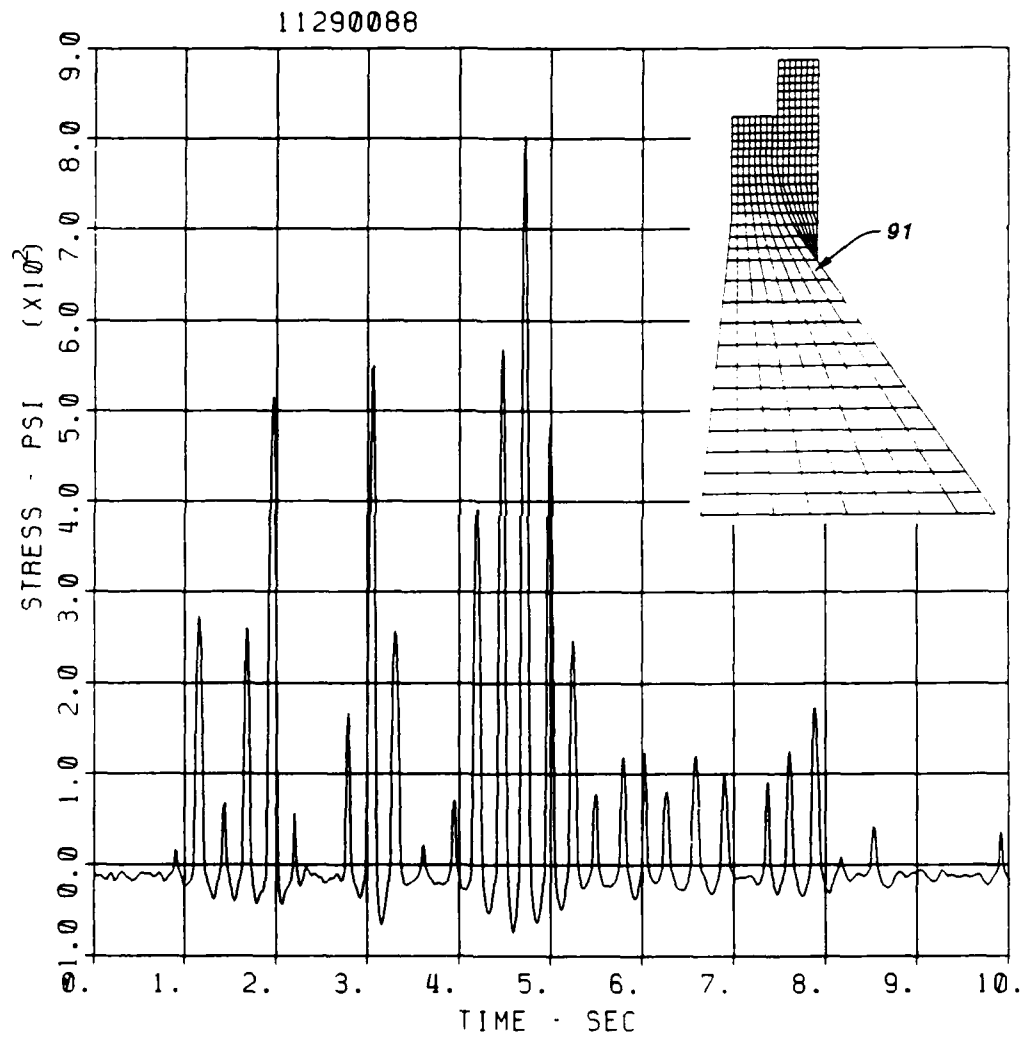
NONFLOW SECTION WITH SIGMA-1 ELE NO. 91

Figure F16. Principal stress time history for element 91

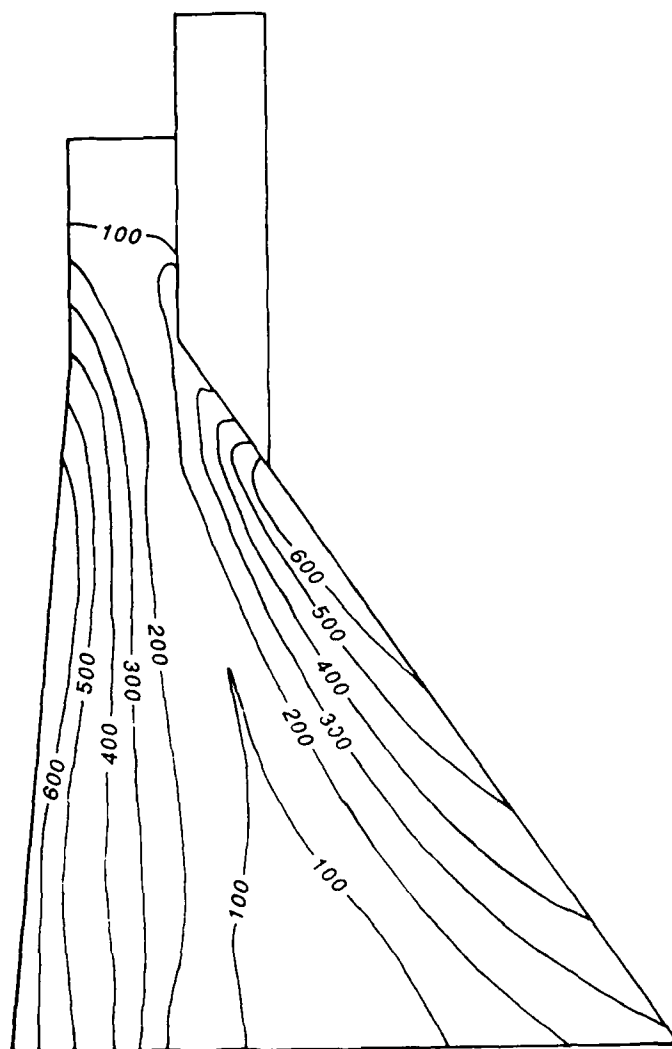
Figure F17. Envelop of maximum principal stresses

38. The damage to a concrete dam is not predominantly controlled by the transitory peak tensile stress response. Tensile stresses greater than the maximum allowable tensile stress, which are repeated several times during an earthquake, are more damaging than a single large peak stress. In studies of concrete dams subjected to earthquake motion, a maximum repeatable stress level is defined as the maximum stress value that is exceeded by six short duration excursions (US Army Engineer District, Sacramento 1986). Figures 22 and 23 indicate that the maximum principal stresses occur at elevation 196, which corresponds to element 120. Figure 24 displays the maximum principal stress in element 120 as a function of time for Case 3. This figure indicates that the maximum tensile stress exceeds the recommended tensile strength of 700 psi for lean concrete only once during the entire earthquake, and that the maximum repeatable tensile stress is approximately 390 psi.

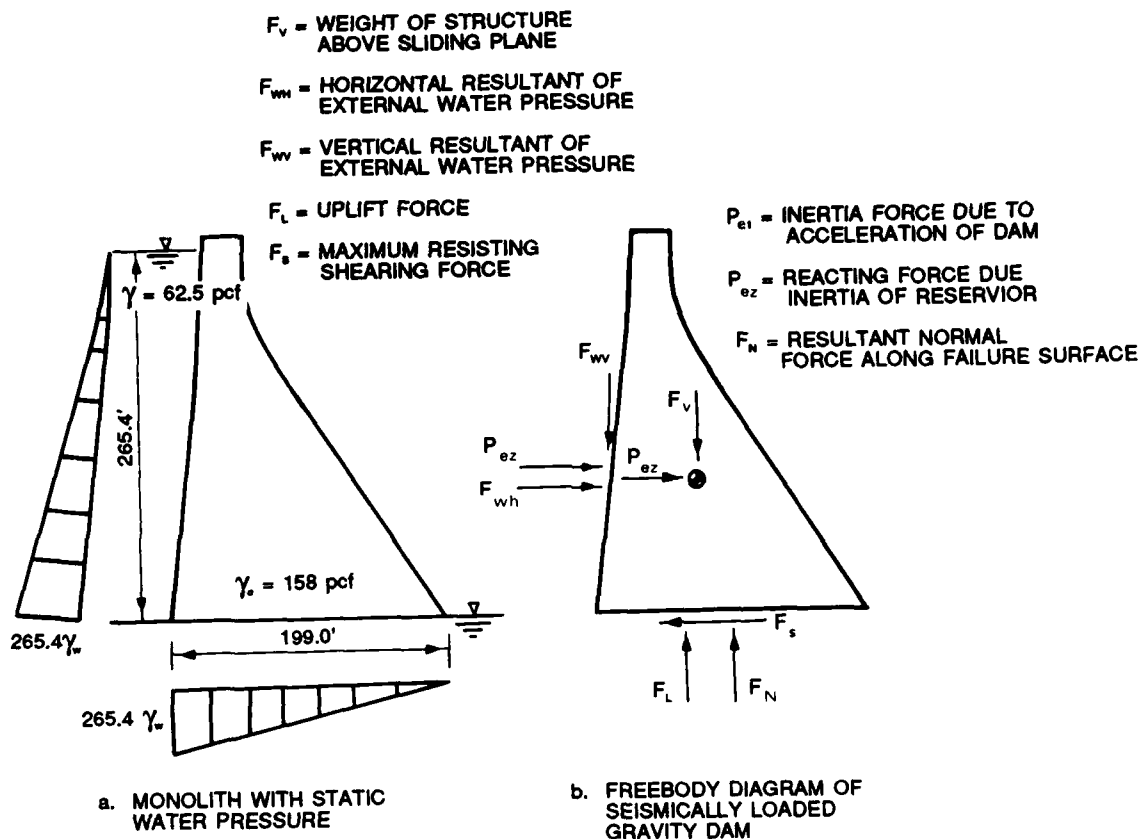
$$F_{wh} \text{ with } \gamma_w = 62.5 \text{ pcf} = 2201,151 \text{ psf} \quad F_L = \frac{1}{2} (199)(265.4) \gamma_w = 1,650,456 \text{ psf}$$

$$F_{wv} \text{ with } \gamma_w = 62.5 \text{ pcf} = 205,919 \text{ psf} \quad F_v \text{ with } \gamma_c = 158 \text{ pcf} = 4,169,411 \text{ psf}$$

1. A stability analysis was performed in accordance with ETL 1110-2-256 (US Army Corps of Engineers 1981). The analysis is limited to horizontal planes at or above the monolith-foundation plane. A seismic coefficient of 0.15g was obtained from ER 1110-2-1806 (US Army Corps of Engineers 1983) for computation of the inertia force due to acceleration of the monolith. The inertia force due to the reservoir water was determined using Westergard's formulation as described in ETL 1110-2-256. The uplift force at the foundation contact plane was based on the assumption of a straight-line variation from full headwater pressure at the heel to zero pressure at the toe for the reservoir level at the spillway flood pool elevation of 475.4. For planes within the monolith, the uplift force was based on a straight-line variation from 50 percent of full headwater pressure at the heel to zero pressure at the toe. A value of 158 lb/ft³ was used for the density of the monolith concrete.
